## CONSERVATION PLAN

WOODEND METHODIST CHURCH

The purpose of this Conservation Plan is to identify and define the cultural heritage values of the Woodend Methodist church to identify influences on its future development, and to define limits to change.

IAN BUTCHER ARCHITECT

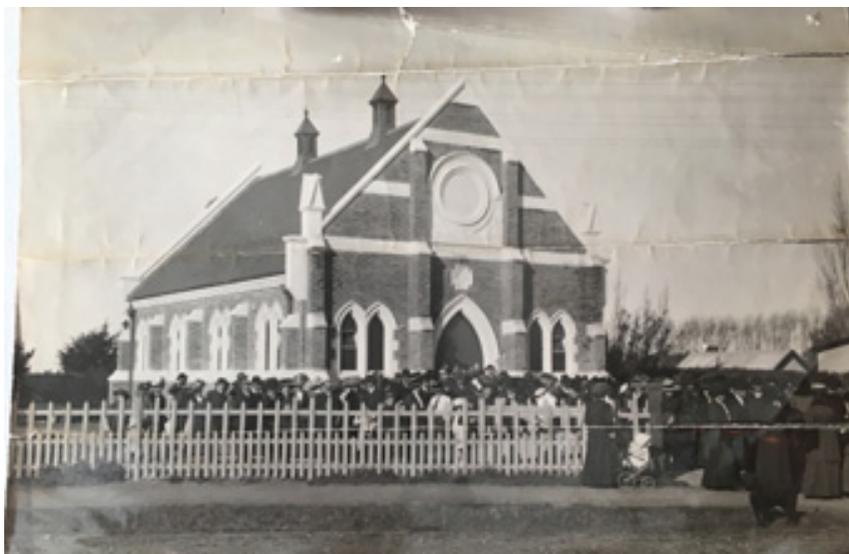
Methodist Church of NZ Archives

Since 1911 (until September 2010) the church building was in good condition and doing the job as the fundraising parishioners had hoped for. Records indicate some additional work being done over the past century such as removal of the ridge vents in the photograph above.

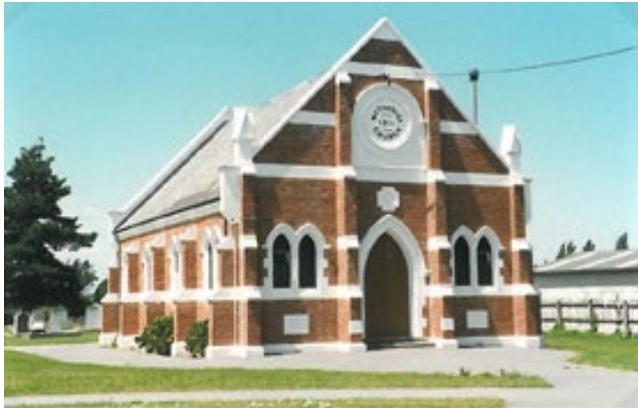
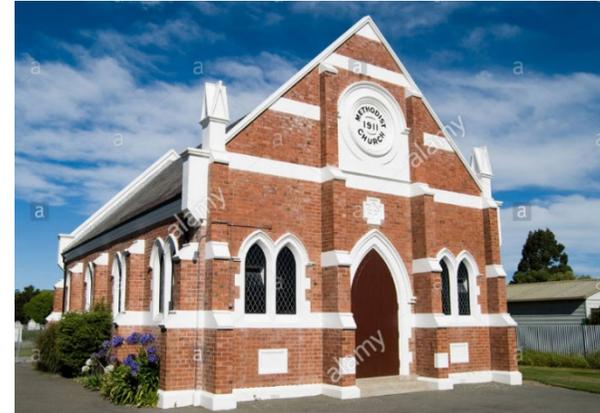
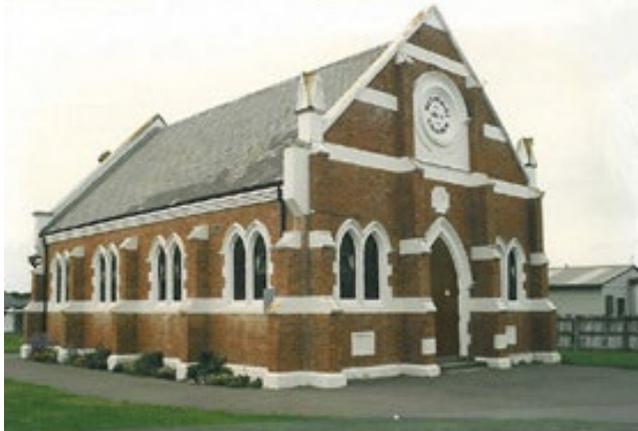
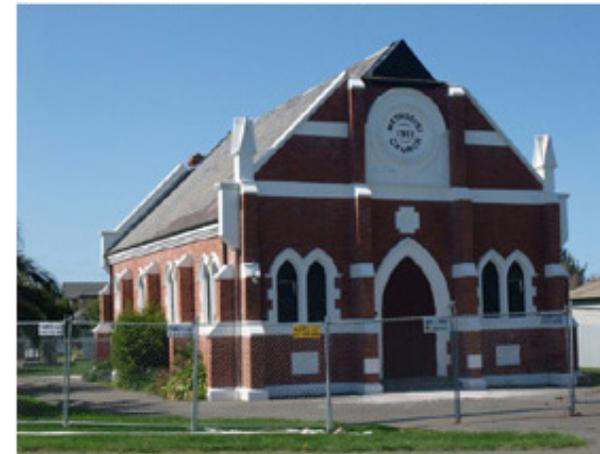
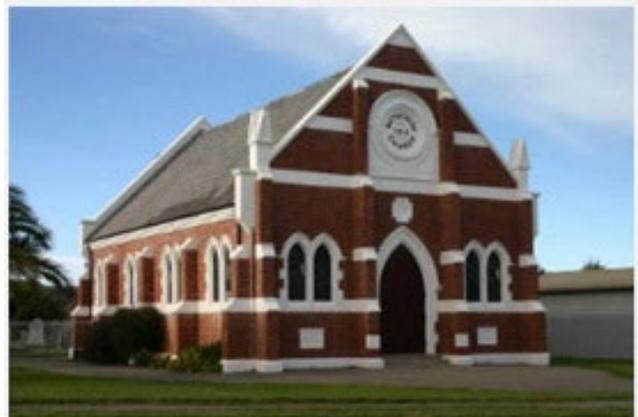
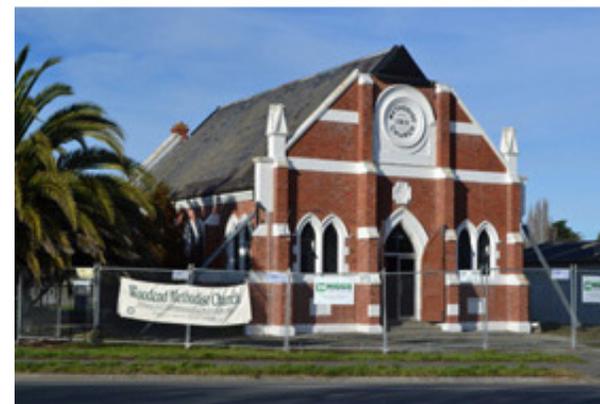
These photographs from a variety of sources, illustrate maintenance by the Church from 1980's to the present day.

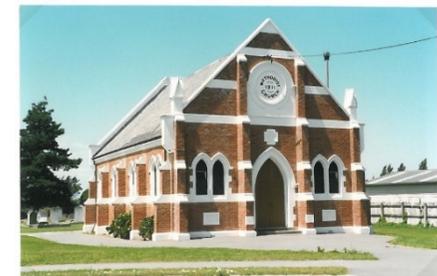
85. Methodist Church: 86 State Highway 1, Woodend  
from Waimakariri District Council Building

The building is constructed of load bearing red brick masonry decorated with white painted plaster in horizontal bands, window surrounds and copings, with the vertical elements and pair of pinnacles with cross-

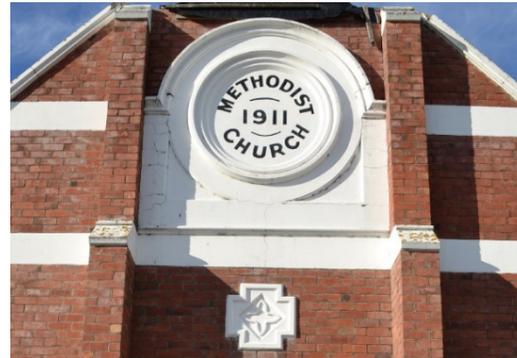
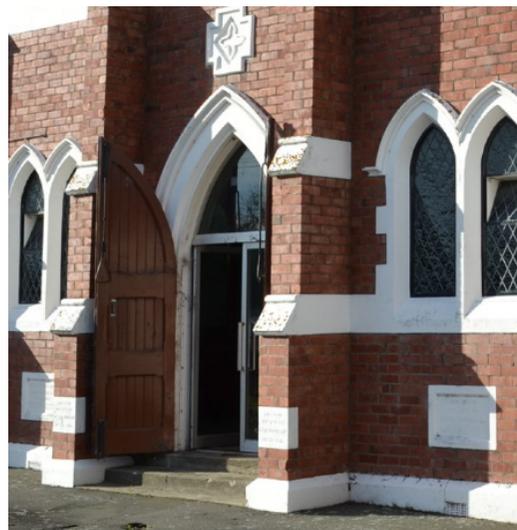
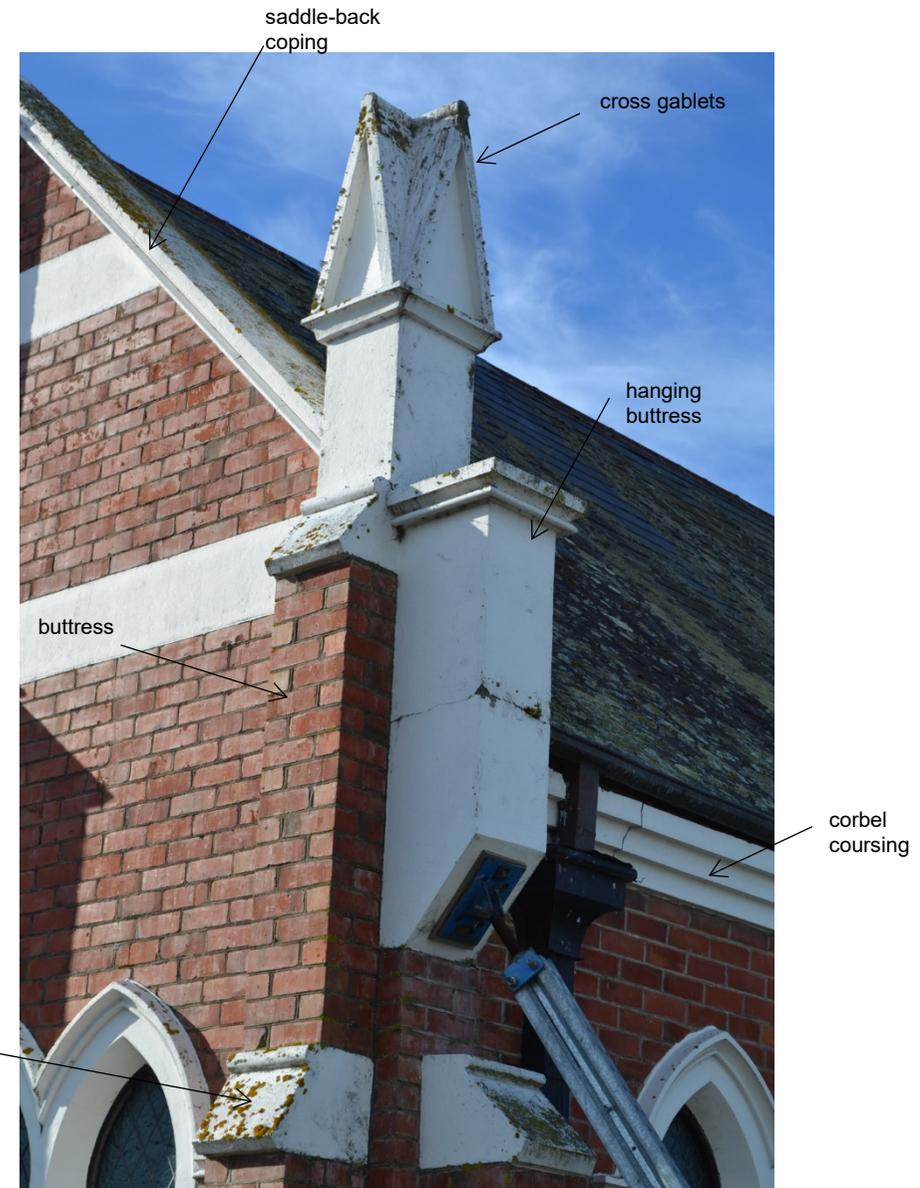
**FOUNDATION STONES**

Four foundations stones in white painted Oamaru stone have been laid, one to each buttress on the west façade.

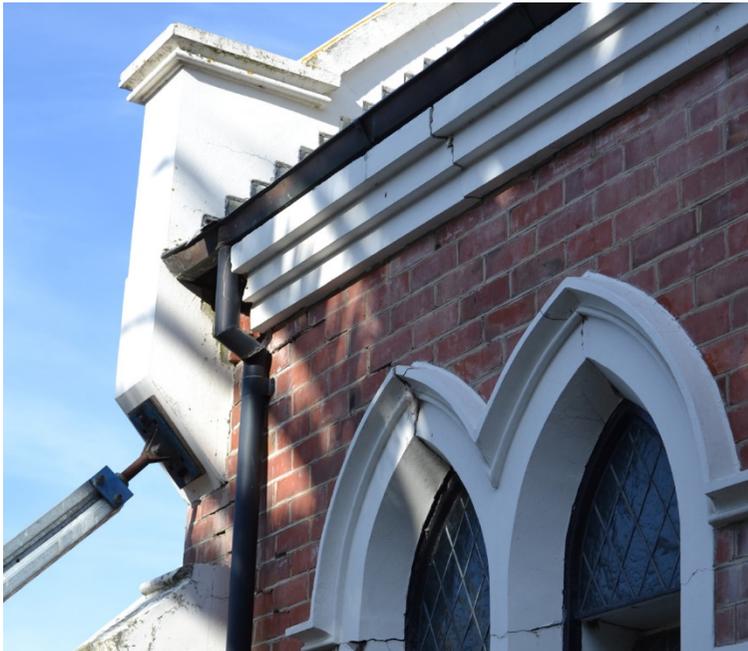
The spouting is copper with an angled flat-fronted profile, and folded top edge and exposed external brackets. Downpipes are also in copper, round profile with holder batts fabricated from flat copper sheet.

The spouting is supported at the top of the side walls on plastered corbel coursing of three steps.

Many slates were broken and lost from falling parapets in the recent earthquakes.

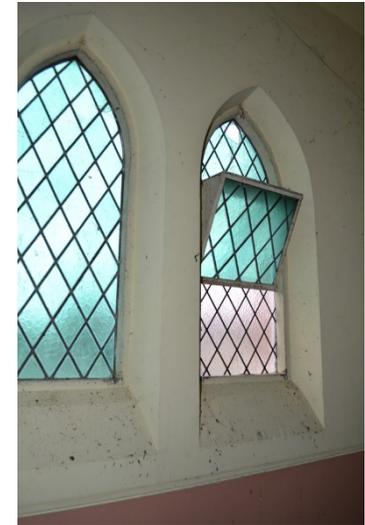
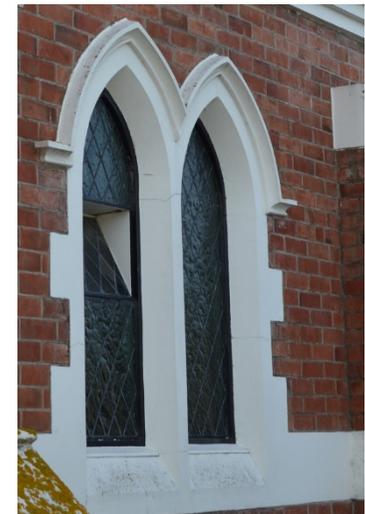
Windows are arranged in pairs, with each pair placed centrally between the buttresses on each side in the Nave, and symmetrically each side of the doors in the street façade. The Vestry has a pair of windows in the south wall and a single window in the north wall. All windows are timber frame with diamond shape leadlight canes with obscure glass. Most of the glass is green tint, and a small amount in the south wall to the Vestry has been replaced with clear obscure glass of matching pattern. Each pair of windows has a steel framed hopper shaped sash that has a fixed horizontal panel, which originally acted as an open vent. Nave windows are about 25 brick courses high, whereas Vestry windows are about 20 brick courses high and they are the same width.

The windows are shaped with an equilateral arch at the top (sometimes referred to as a Gothic arch), and trimmed on the exterior with plaster frames, stepped facings and plaster hood moulds that terminate in an elegantly shaped label-stop drip edge to each side.

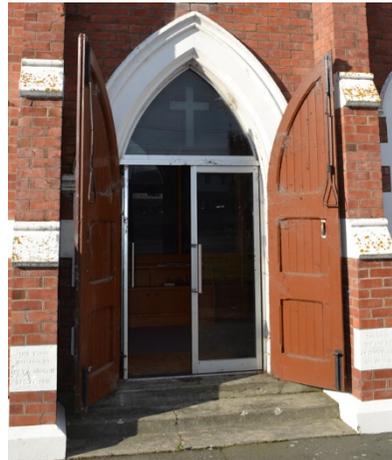
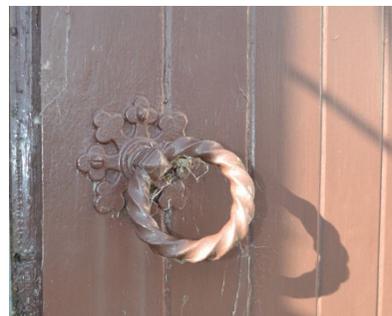
The doors have arch shaped tops similar to the windows and are fitted with heavy steel hardware including long bolts at the top and square shank tower bolts at the bottom that terminate into square keeper plates fixed to the concrete threshold. The robust, ring shaped door handles are rope profile twisted metal with floral shaped rose plate screw fixed to the face of the door.

A pair of inward opening aluminium doors have been added to the inside to provide additional weatherproofing.

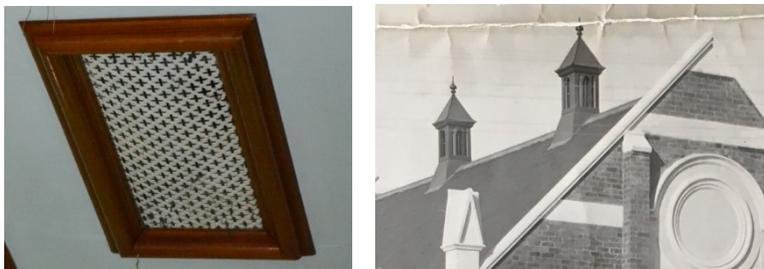
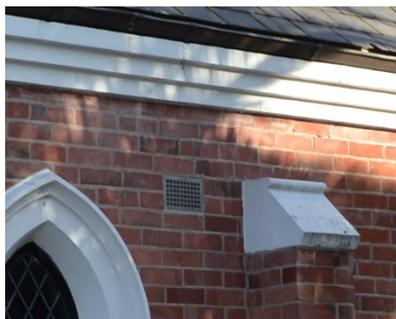
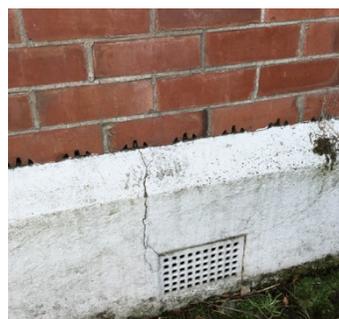
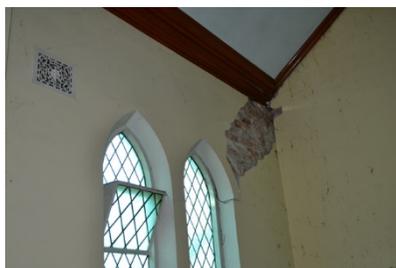
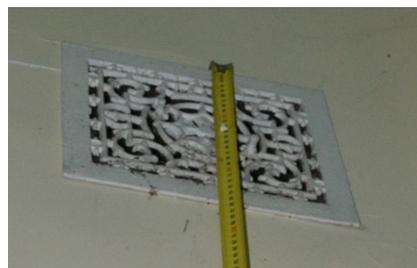
The brick walls are constructed with two walls of brick, one brick thick (110mm) each, in simple stretcher bond separated by a draining and venting cavity about 100mm wide. The technique is to allow drainage of any moisture that penetrates the outer wall thus preventing water ingress to the building interior, and to ventilate the cavity to keep the inner wall of brick dry. Weep hole slots have been cut in the lowest course of brick, a departure from the more common practice of raking out every third or fourth perpend.

allowing ventilation to exterior and interior of the cavity. Two roof vents were located equidistant along the ridge. Windows are fitted with steel venting hopper shaped sash with (formerly) open top. The building therefore has technical heritage significance.

The likely reason for the emphasis on ventilation was concern for the health of the building users. Influenza was a killer disease in the late 19th and early 20th centuries, with pandemics in 1890's and 1918<sup>83</sup>. Many thousands of people died in New Zealand. The prevailing public health advice at that time was to ensure good ventilation was provided in buildings used for crowd gathering. One obituary for Robert England is that he had suffered a long illness and died from influenza. With Robert's death still in his mind, Edward would have completed the design for the Woodend church and it seems highly likely he would have incorporated the latest design measures to mitigate against disease. We speculate therefore this was the reason for the close attention paid to the provision of ventilation.

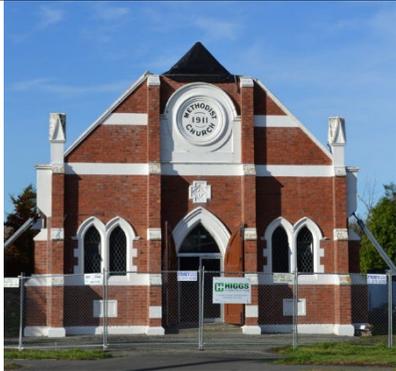
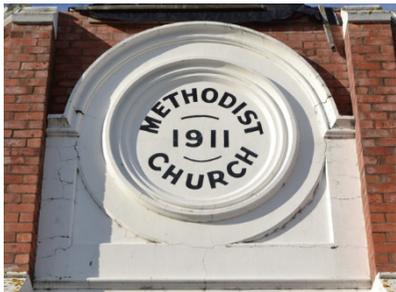
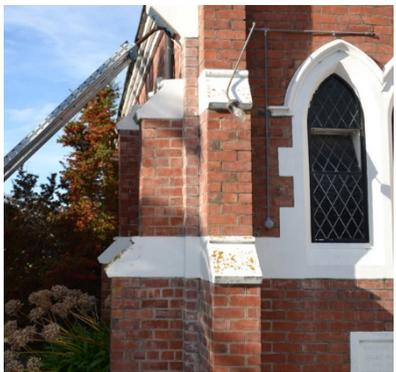
EXTERIOR Element	History / Key Values / Issues	Conservation Management
<b>West Façade</b>

<p>EHV; Unchanged since construction; High integrity; Positive streetscape contribution; White paint to plaster detail, plaster Medallion, Oamaru stone spires with gablets atop hanging buttresses, and other decorative elements. Leadlight glazing to pairs of side windows. Timber entry doors and hardware. Signage on medallion. Oamaru Foundation stones.</p> <p>Recent earthquake damage includes; Upper gable parapet collapsed (was white painted triangular apex); cracking to brickwork and plastered elements; Cracking to and collapse of saddle-backed coping to parapet.</p> <p>Note buttresses leaning to the left on side wall.</p>	<p>Retain, repair and conserve bulk, form, detail and original fabric, brickwork unpainted and uncoated. <b>DO NOT WATER BLAST BRICKWORK.</b> Repair Oamaru stone. Repaint window frames in original colour; Add unobtrusive new equipment if needed for adaptive reuse e.g. discrete security system. Repair original electric light and metal conduit to original position and condition. (refer to photo "85. Methodist Church: 86 State Highway 1, Woodend". Ensure all new and replacement items of building fabric match the original in profile, detail, form, material, finish and colour. Repoint brickwork.</p>

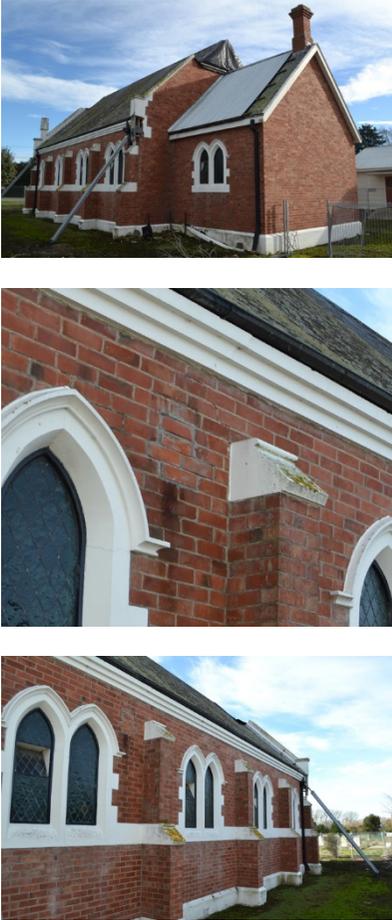
EXTERIOR Element	History / Key Values / Issues	Conservation Management
<b>South Façade, Administration Block</b>

<p>EHV; Unchanged since construction; High integrity; White paint to plaster detail and Oamaru stone decorative elements. Leadlight glazing to pairs of windows. Painted corbel coursing to top of wall at spouting level.</p> <p>Recent earthquake damage includes;</p> <p>Patch repair where heater flue was removed in 1994.</p> <p>Lower part of southern hanging buttress and corbel collapsed; severe cracking to brickwork in upper right and left where south wall meets end walls; cracking to brickwork in buttresses cracks to plastered window elements; damage to</p>	<p>Retain and conserve bulk, form and original fabric, leaving brickwork and uncoated.</p> <p><b>DO NOT WATER BLAST BRICKWORK.</b></p> <p>Keep painted Oamaru stone painted. Repaint window frames in original colour.</p> <p>Repaint all plaster work and timber. Remove sand &amp; cement pointing and bricks to area where heater flue exited. Relay brick with lime mortar and pointing to match existing. Ensure all new and replacement items of building</p>

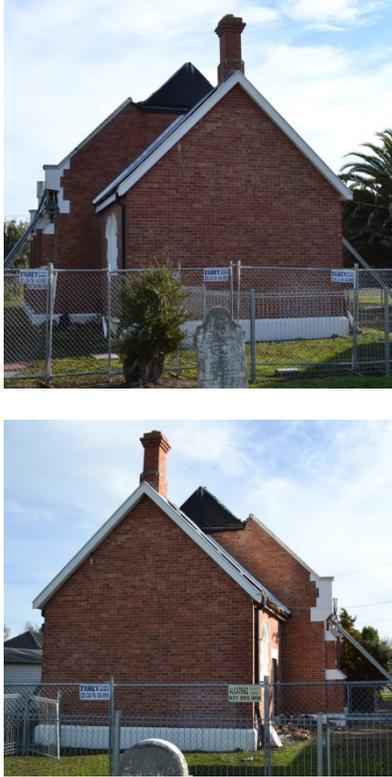
EXTERIOR Element	History / Key Values / Issues	Conservation Management
<b>East Façade</b>

<p>EHV; Unchanged since construction; High integrity; White paint to plaster detail decorative elements. Chimney appears in good condition with corbel coursing to top of flue.</p> <p>Recent earthquake damage includes;</p> <p>Upper gable parapet collapsed (was white painted triangular apex). Lower part of southern hanging buttress and corbel collapsed on south side; cracking to brickwork in buttresses.</p>	<p>Retain, repair and conserve bulk, form, detail and original fabric, leaving brickwork unpainted and uncoated.</p> <p><b>DO NOT WATER BLAST BRICKWORK.</b></p> <p>Repaint window frames in original colour; Ensure all new and replacement items of building fabric match the original in profile, detail, form, material, finish and colour. Repoint brickwork.</p>
